**Flood Control Project Maintenance
Levee Inspections**
LMA District Cover Sheet
Spring 2011 Levee Inspection Results

Reclamation District No. 0827 Elkhorn

Levee Inspection Report By Mile - Spring 2011

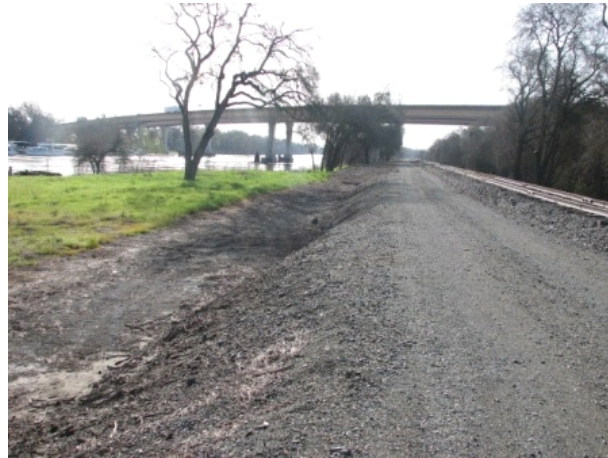
Levee Mile Report Line	1
Start Levee Mile	0.03
End Levee Mile	0.03
Location	Water Side
Category	Earthen Levee
Item	Vegetation

The levee has been sprayed for vegetation.

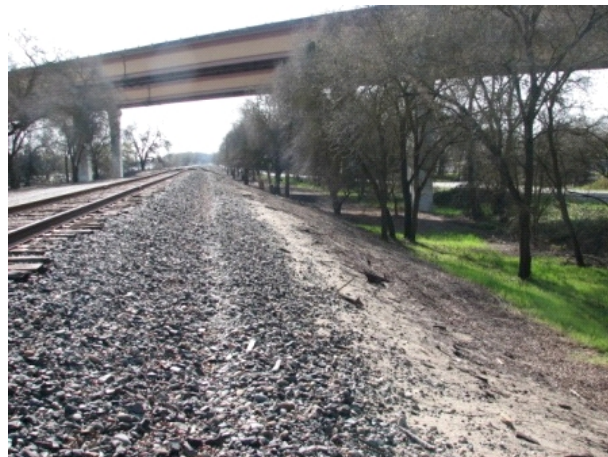
Levee Mile Report Line	2
Start Levee Mile	0.10
End Levee Mile	0.10
Location	Land Side
Category	Earthen Levee
Item	Vegetation

The levee slope has been sprayed of vegetation.

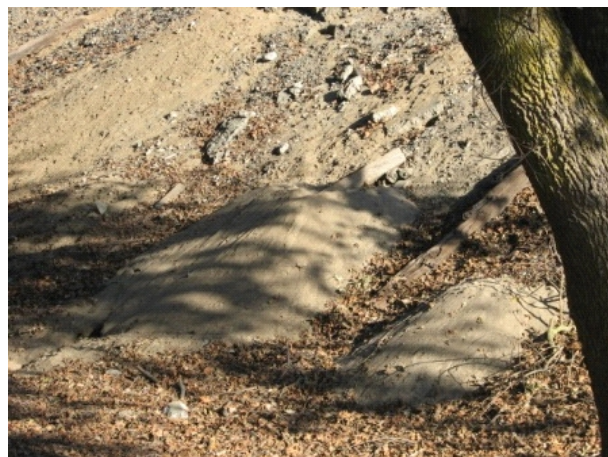
Levee Mile Report Line	4
Start Levee Mile	0.29
End Levee Mile	0.29
Location	Land Side
Category	Earthen Levee
Item	Animal Control

Rodent burrows on the landside levee a large amount of material.

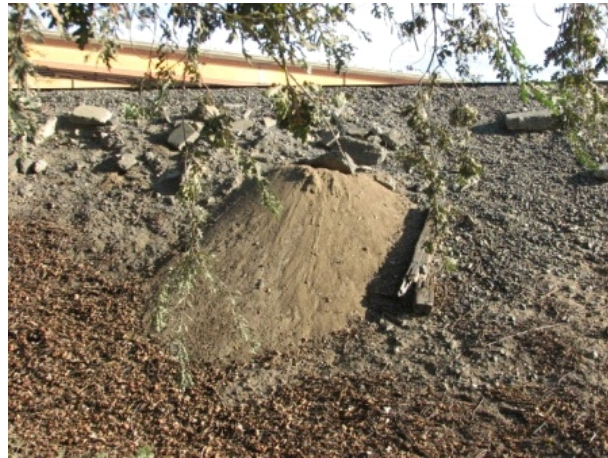
Levee Mile Report Line	4
Start Levee Mile	0.29
End Levee Mile	0.29
Location	Land Side
Category	Earthen Levee
Item	Animal Control
More rodents in the same area with large quantities of material excavated.	
johngw_s_20110228_214.jpg

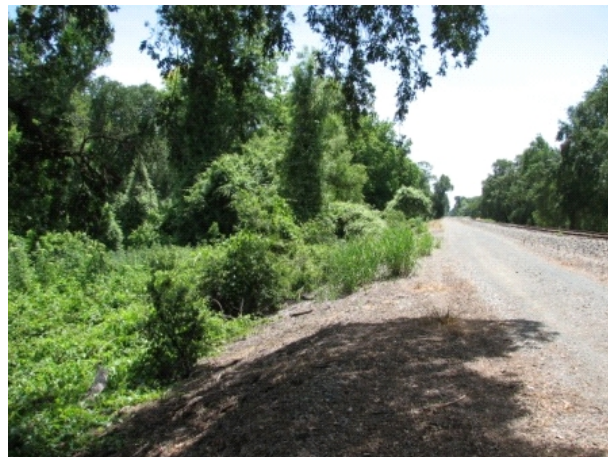
Levee Mile Report Line	11
Start Levee Mile	1.07
End Levee Mile	1.19
Location	Water Side
Category	Earthen Levee
Item	Vegetation
The vegetation needs to be trimmed.	
johngw_s_20110228_211.jpg

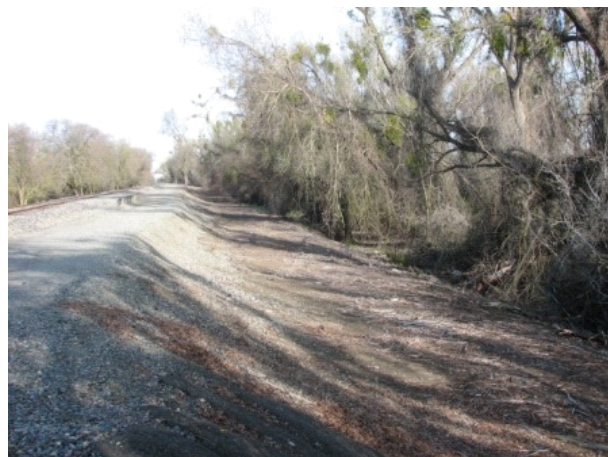
Levee Mile Report Line	11
Start Levee Mile	1.07
End Levee Mile	1.19
Location	Water Side
Category	Earthen Levee
Item	Vegetation
The district has made great improvements in controlling the vegetation.	
johngw_s_20110321_392.jpg

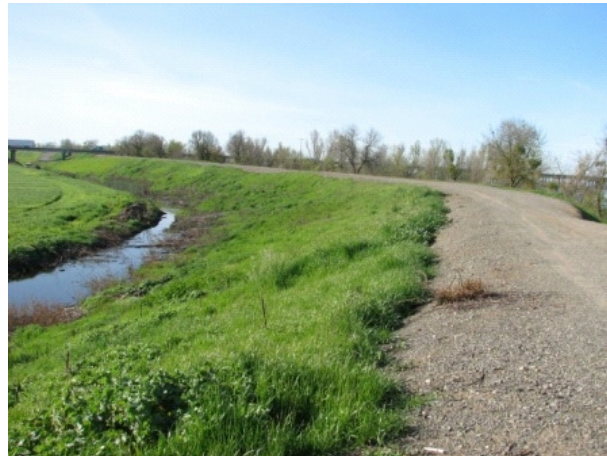
Levee Mile Report Line	1
Start Levee Mile	0.01
End Levee Mile	2.79
Location	Land Side
Category	Earthen Levee
Item	Vegetation
The grasses on the landside complies with standards. Need to mow or burn before fall.	
johngw_s_20110329_401.jpg

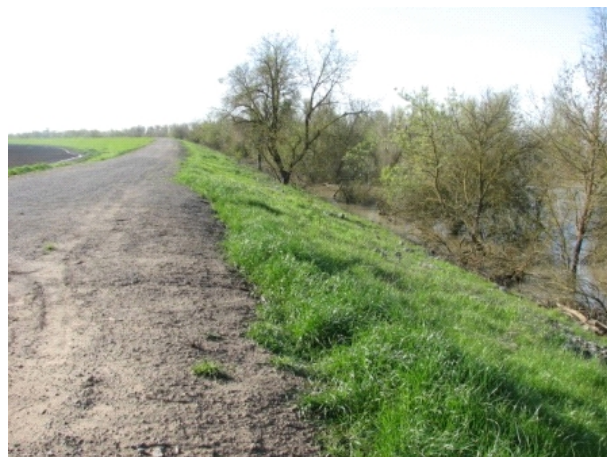
Levee Mile Report Line	2
Start Levee Mile	0.01
End Levee Mile	2.79
Location	Water Side
Category	Earthen Levee
Item	Vegetation
The grasses on the waterside complies with standards. Need to mow or burn before fall.	
johngw_s_20110329_402.jpg

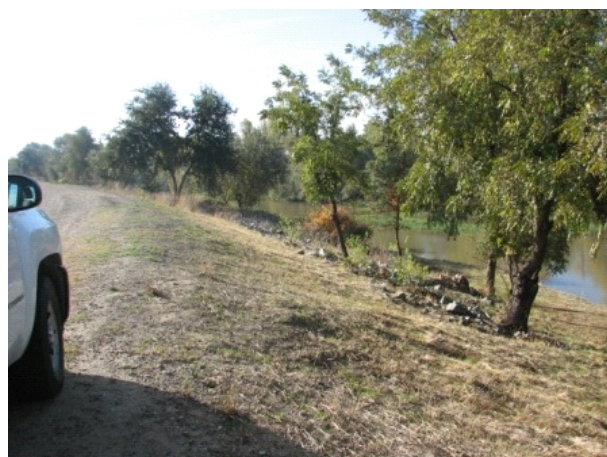
Levee Mile Report Line	3
Start Levee Mile	0.06
End Levee Mile	0.19
Location	Water Side
Category	Earthen Levee
Item	Vegetation
After the goats have gone through the area vegetation is under control.	
johngw_s_20110228_216.jpg

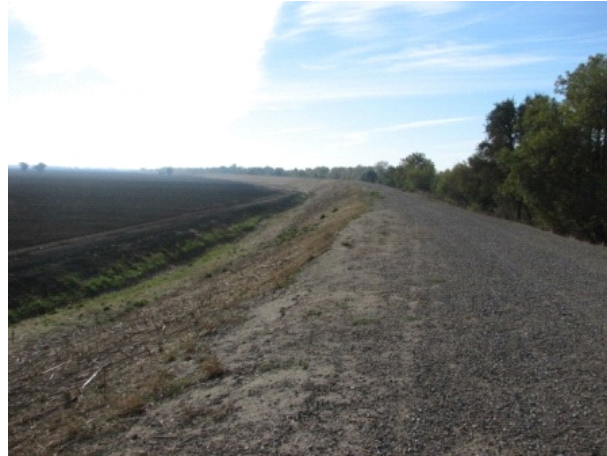
Levee Mile Report Line	6
Start Levee Mile	0.38
End Levee Mile	0.65
Location	Land Side
Category	Earthen Levee
Item	Vegetation

Photo of the landside slope after the goats have worked the area.

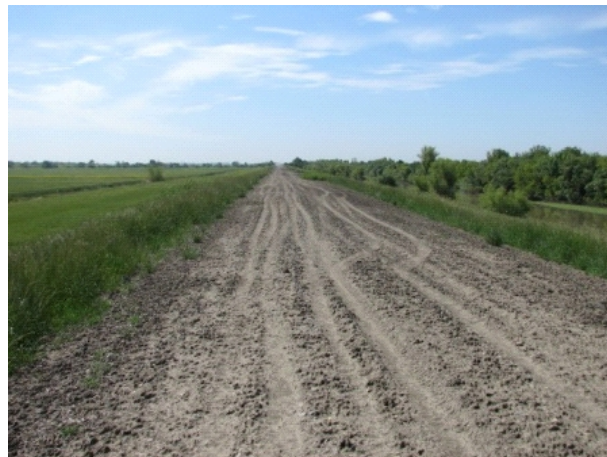
Levee Mile Report Line	7
Start Levee Mile	0.80
End Levee Mile	2.41
Location	Crown
Category	Earthen Levee
Item	Crown Surface / Depressions / Rutting

crown needs grading and AB added
